## Drinking Water System Needs Assessment

**System Name/ID:** Bailey Mutual Water Company / PWSID CA3700926

**Date of Site Assessment:** 03/18/2026

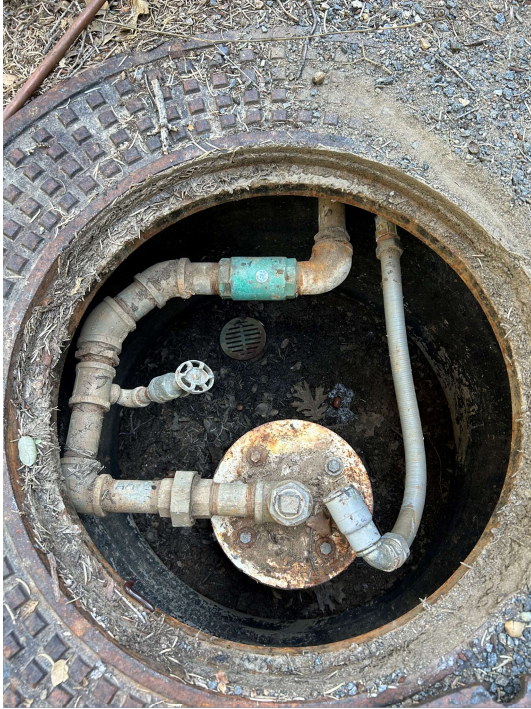
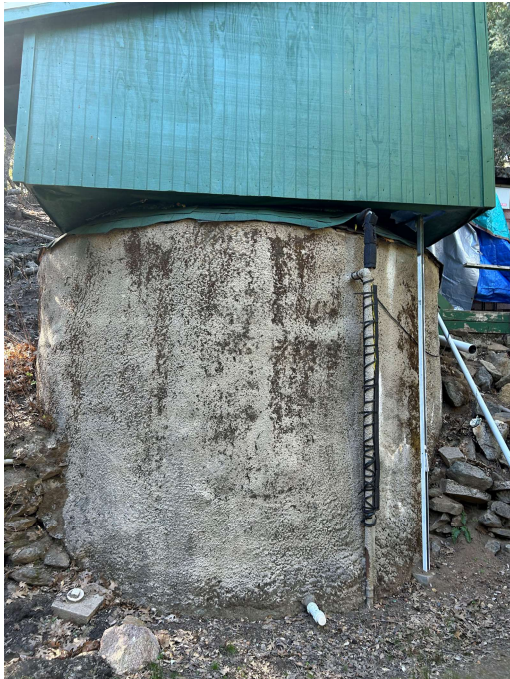
**Description:** Well pump and lower concrete storage tank.

Storage tank capacity: 10,000 gal

The well pump enclosure could benefit from regular inspection and cleaning. The wellhead assembly appears to be in fair condition. There have been modifications to the storage tanks since it's initial construction.

Storage tank has had improvements over time to keep in service, however, longevity and security of the tank is uncertain.

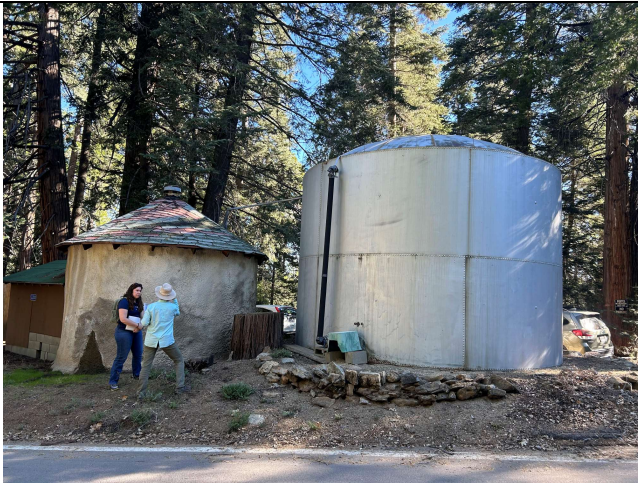
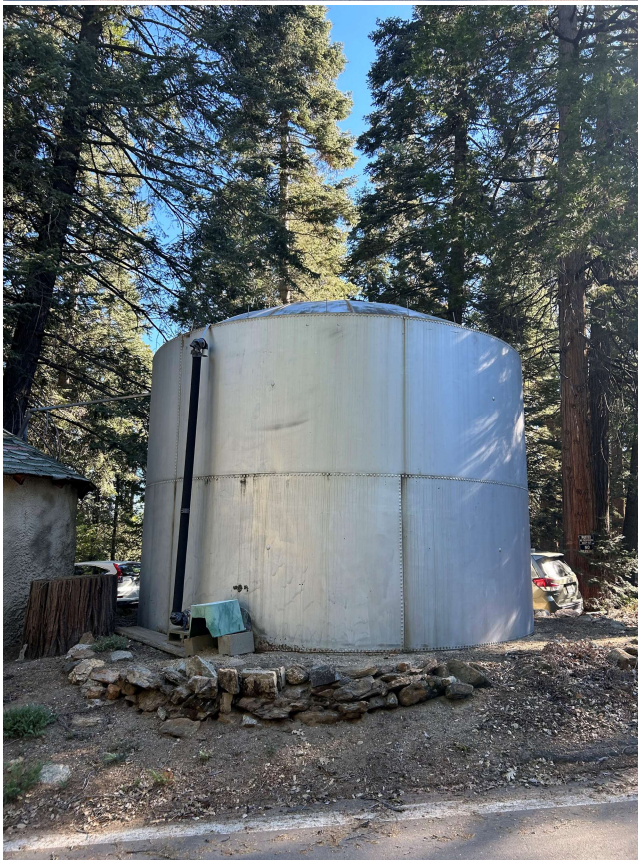
**Description:** Upper storage reservoir tanks.

Redwood tank (left)- installed in 1977. Steel coating inside of tank. Capacity: 8,000 gal. Not in operation.

**Observations:** Redwood tank likely requires replacement and is not being used for storage.

- Finish all outstanding State permit application items.
- Complete TMF documentation and required source water monitoring.
- Resolve State-cited deficiencies, including:
  - Replace or address the 8,000-gallon storage tank.
  - Replace or address the 10,000-gallon transfer/storage tank.
  - Redesign or replace the 25,000-gallon steel tank overflow.
  - Resolve cross-connection concerns with the adjacent resort.
- Adopt and implement a formal Cross Connection Control Plan.

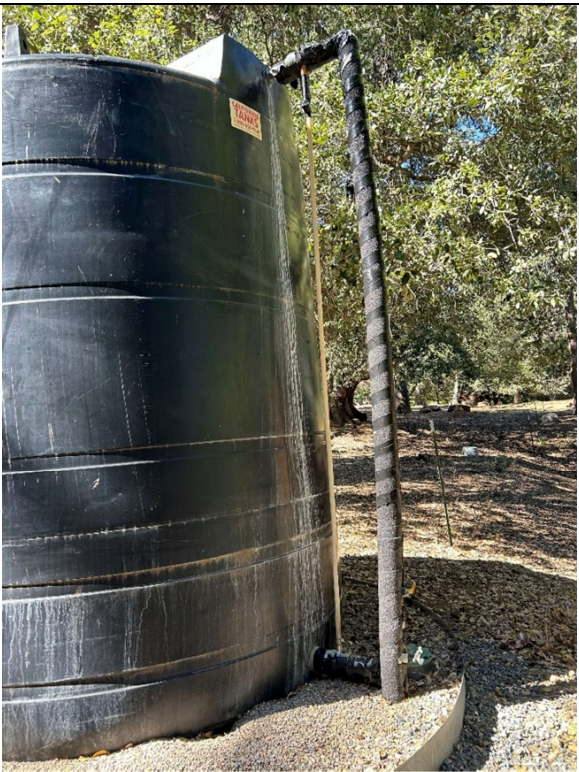
| | <p><b>Description:</b> Upper fire storage tank. Capacity: 3,000 gal.</p> <p><b>Observations:</b> Tank is in use and on private property of BMWCo board member. Tank is in good condition and is in use. Backflow preventer needed.</p> <p>-</p> |

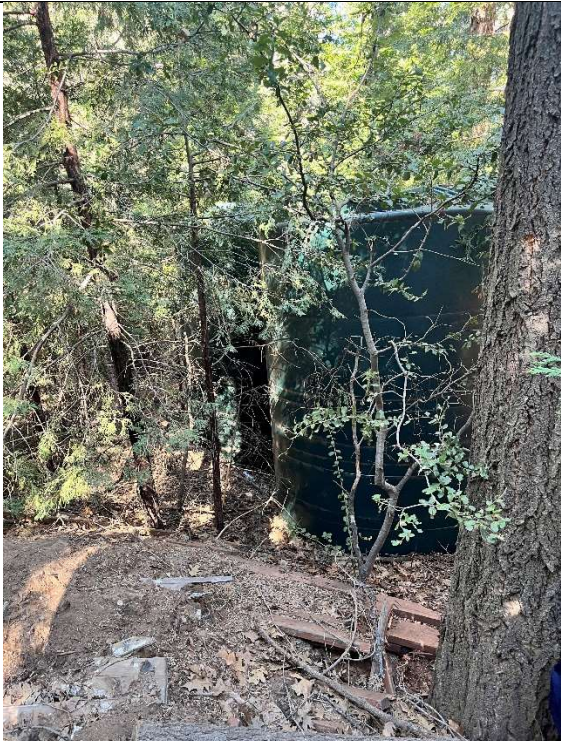
| | <p><b>Description:</b> Lower fire storage tanks. 2 identical tanks. Capacity: approximately 5,000 gal each. Tanks are empty and not in use. Valves are closed off to distribution system. Managed by homeowners of property they are installed on.</p> <p><b>Observations:</b> Tanks appear to be in fair condition. Unknown history of inspections or repairs.</p> |
